NSWC/DL-TR-3904

4. TITLE (and Subtitle) FABRICATION AND ASSEMBLY OF A SHIPBOARD MULTI-FUNCTIONAL WASTE INCINERATOR (MFI). PHASE II	5. TYPE OF REPORT & PERIOD COVERED Final rept.

7. AUTHOR(s) F. Crowson, J. A. Byrne W. W. Jones	8. CONTRACT OR GRANT NUMBER(s)	
9. PERFORMING ORGANIZATION NAME AND ADDRESS Naval Surface Weapons Center (G51) Dahlgren Laboratory Dahlgren, VA 22448	10. PROGRAM ELEMENT, PROJECT, TASK AREA & WORK UNIT NUMBERS NAVSEA WR N0002478: WR 8G140: CG43KE3

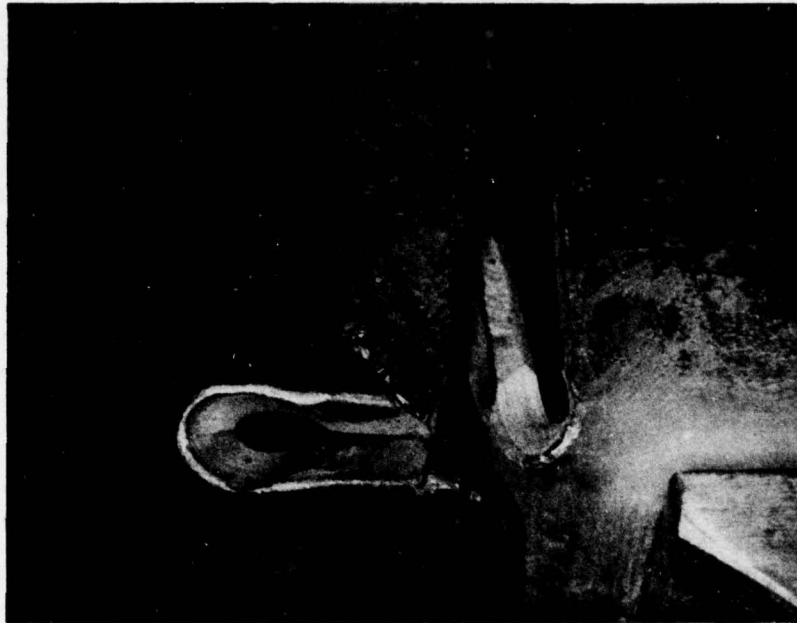
Figure 1. Detail of Corner Fabrication

The side and end panels were fabricated by drop-shearing a 1/4-in. mild steel plate to include sufficient material for flanges. Corners were drilled at intersections of the flange ends, and the corner pieces were removed using a saw-cut. The 90° flanges were bent to approximately a 3/8-in. inside radius using a Cincinnati press brake with a 1/4-in. radius upper die and a 3/4-in. radius lower die. The resulting corner prior to welding is shown in Figure 1. All sharp edges were rounded to relieve high-stress areas that occur during the bending. The sewage chamber panels were fabricated in the same fashion.

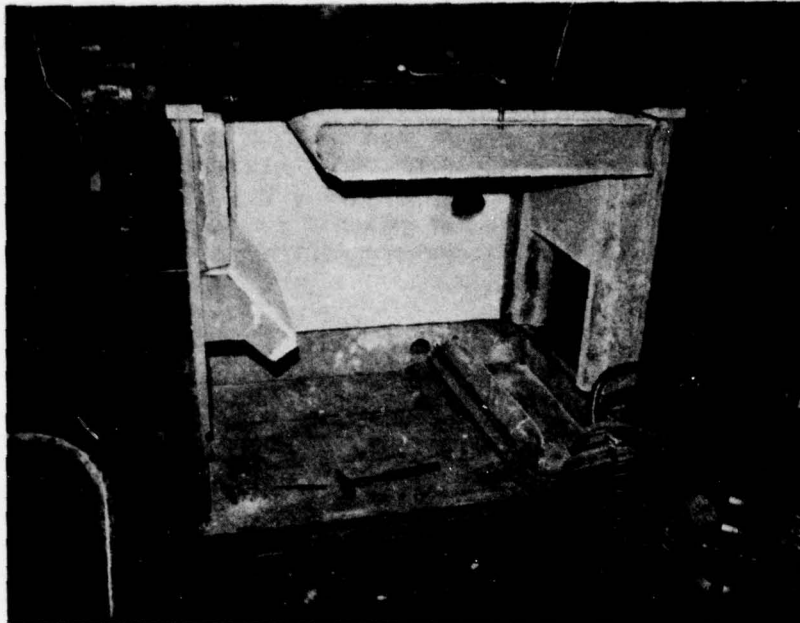
Figure 8. Partial Assembly of Firebox

Figure 7 shows the sewage chamber walls: one wall partially cast, and the other wall completely cast. The oval-shaped exhaust port can be observed on the fully cast wall. The cast firebox module was assembled as shown in Figure 8 to check for alignment. The forward wall, the right (burner) side wall, and the rear wall are shown in position. The left side panel cracked diagonally when alignment pins were used to align bolt holes. The panel was recast within 2 hr and after curing, was refit to the module. A small crack about 6 in. in length occurred again upon assembly across the upper right corner. This crack was small enough to be patched with Greencast 97 fines.

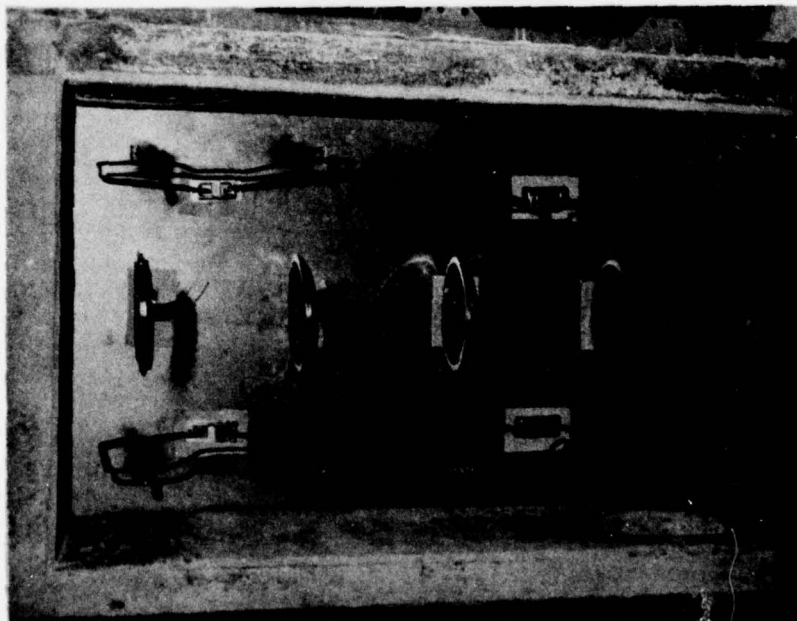
Figure 9. Heating Elements for Jade Pak Cure

Before the sewage chamber was installed, the Jade Pak 88 plastic refractory was cured for 28 hr, during which time the temperature was raised 50°F/hr to 700° with three hold periods (5 hr each) at 225°, 525°, and 700°F. The sewage chamber enclosure was covered top and bottom with insulating board, and the total assembly was wrapped with 2 in. of fiberglass insulation. Curing of the Jade Pak was performed using electrical heater elements (Figure 9).

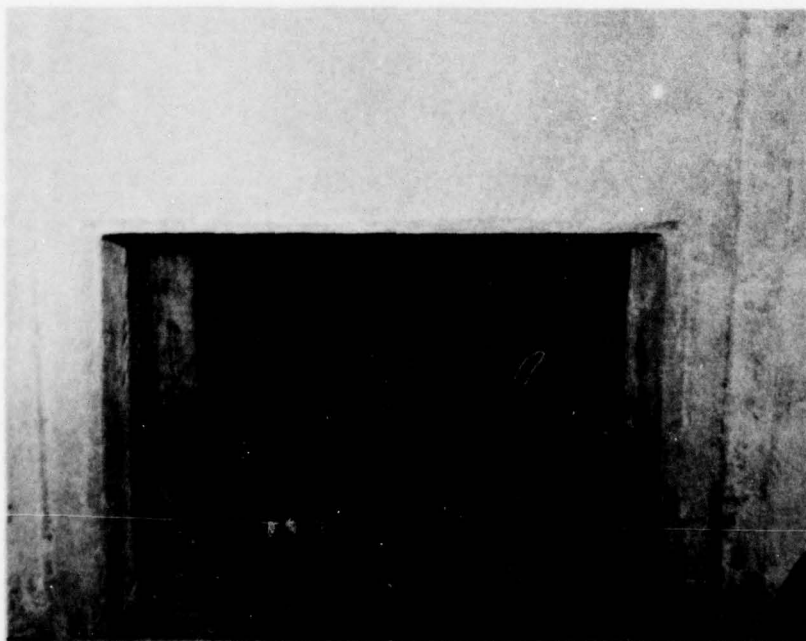
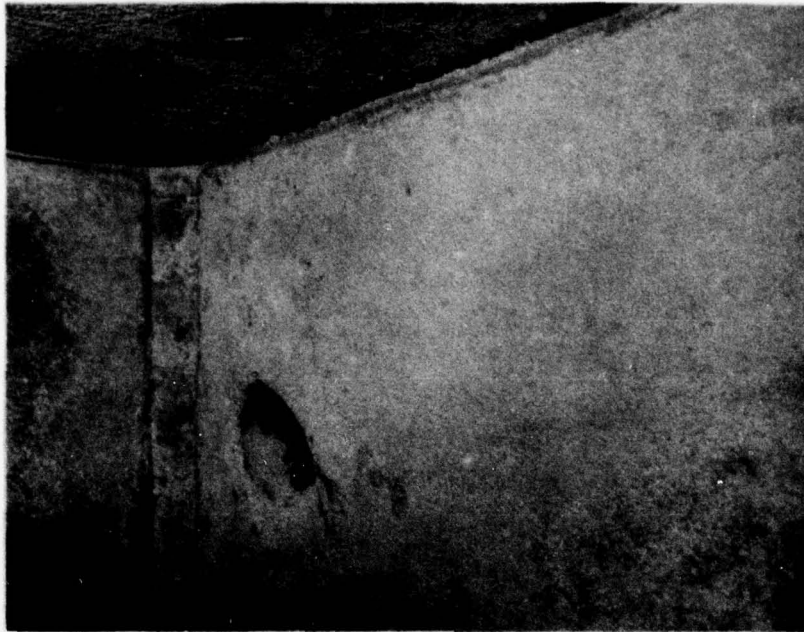
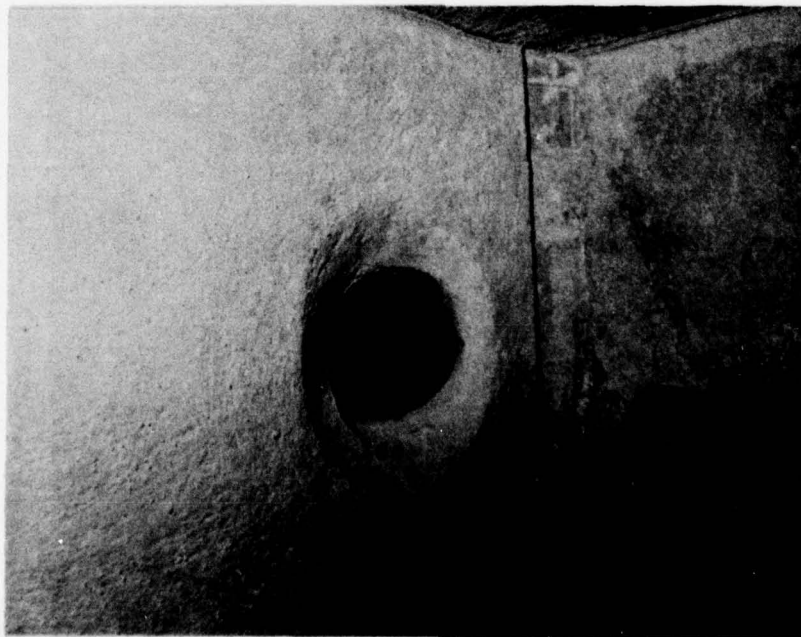
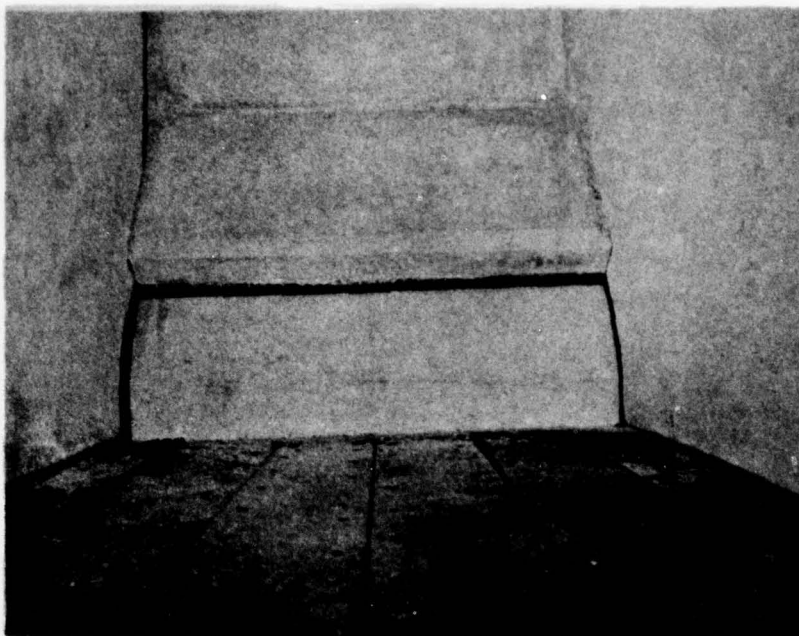
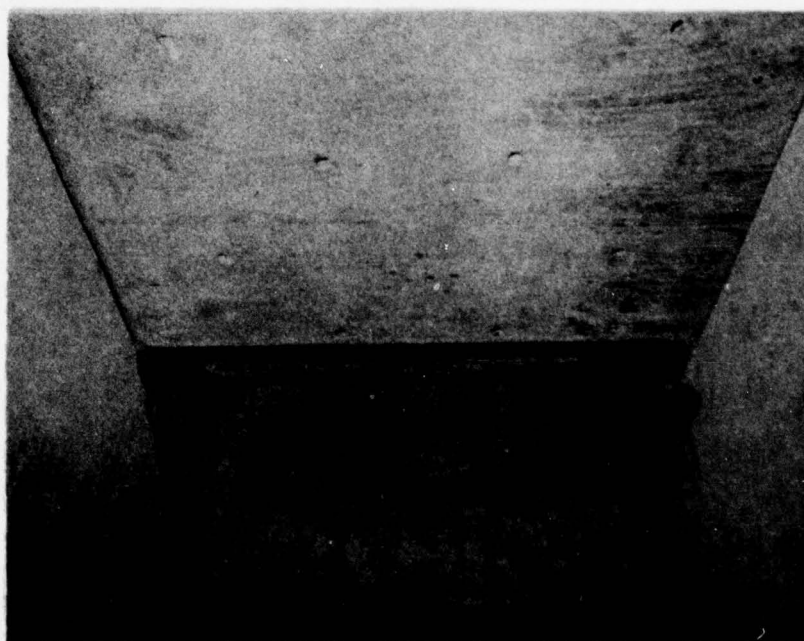
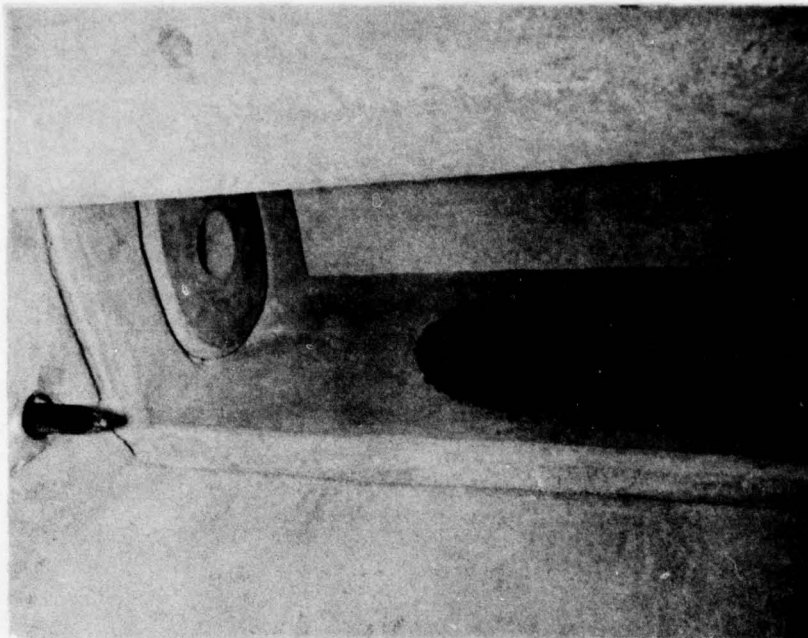
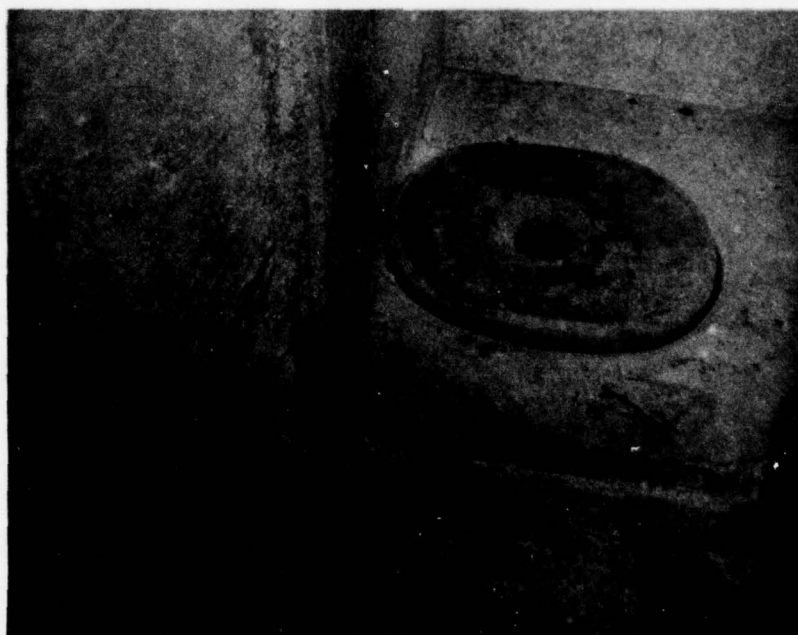
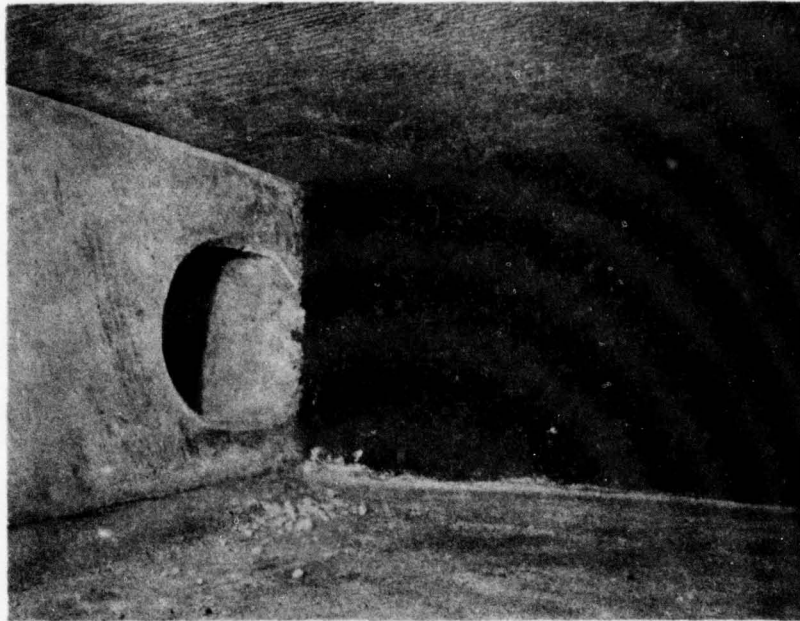
The fully assembled unit is shown in Figure 16, an isolated picture of the flyash collector is presented in Figure 17, and the sewage nozzle assembly installation is shown in Figure 18. Complete photodocumentation made of the interior of the incinerator prior to curing (Figures 19 through 26) shows that all casting appears to be in excellent condition.

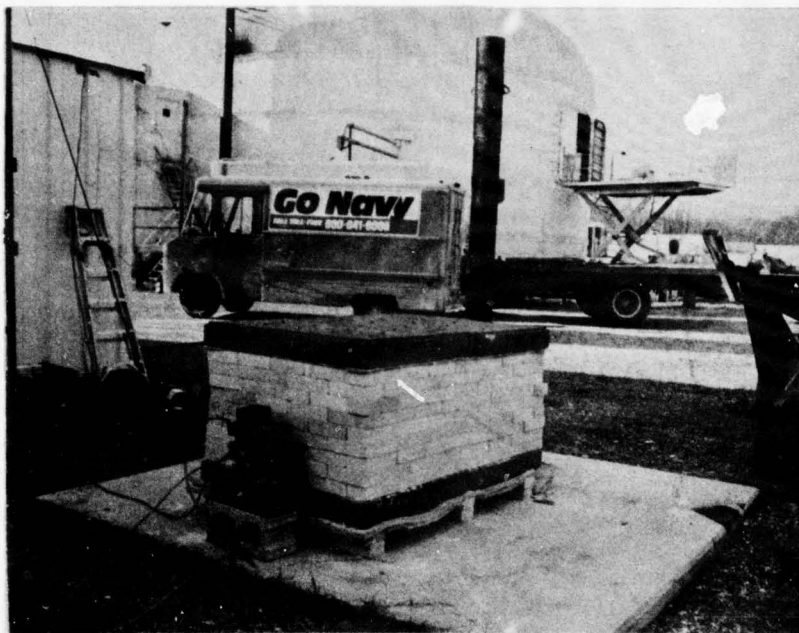
Figure 27. Assembly for Curing Test Panels

The incinerator in situ and the extra sewage enclosure tops were cured simultaneously. The assembly used to cure the tops is shown in Figure 27. Lightweight insulating firebrick was used to construct the enclosure. Photographs taken before curing showed no cracking. Curing was performed in accordance with the manufacturer's recommended schedule; that is, the temperature was gradually increased at a rate of  $50^{\circ}\text{F/hr}$  with five hold periods (6 hr each) at  $300^{\circ}$ ,  $525^{\circ}$ ,  $1025^{\circ}$ ,  $1800^{\circ}$ , and  $2150^{\circ}\text{F}$ . A small burner was utilized through the feed door to bring the incinerator to  $300^{\circ}\text{F}$ . Thereafter, the main burner and its controller were used.
